**An Archaeological Watching Brief
at
St. Peters's Church
Staple Fitzpaine
Somerset
SFC 13**

Carried out for: Staple Fitzpaine Parish Council
Grid Reference: ST 2640 1826

Report Number 495

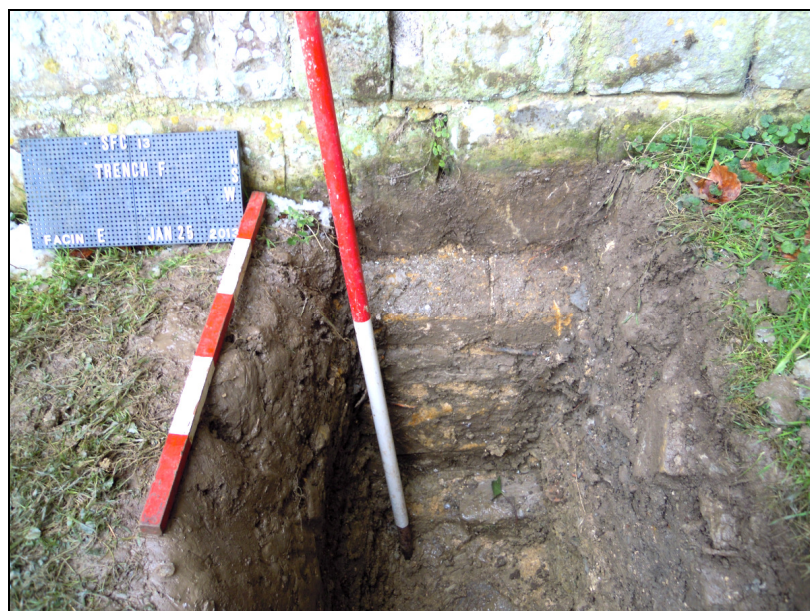
The west wall of the north aisle of St Peter's church was exposed in **Trench F** at a point approximately 0.3m north of the north wall of the tower. **Trench F** was excavated to a depth of 0.6m revealing a lower chamfered offset of three courses sitting upon another offset. These lower courses, originally exposed to public view, have been obscured by gradual build-up of the level of the graveyard from the fifteenth century.

Photograph 2. Outer wall of north aisle, Trench F, looking South

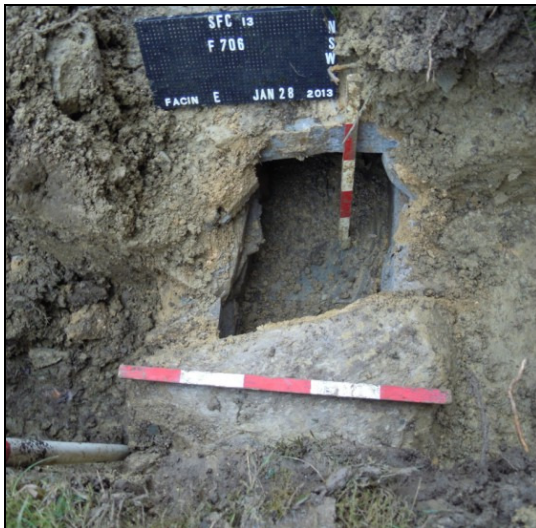
7.3.1 Culvert (706) was the first of these features to be revealed. One of the capstones was removed in order to confirm that this feature represented a culvert. No dating evidence was recovered from the culvert or any associated deposits. Because culvert (706) was essentially intact (although no water was observed flowing within it despite the ground being saturated) it was necessary to leave it in place and mole beneath it. **Trench G** was subsequently extended by a further 2m to the SE in order to provide an exit point for the mole.

Photograph 3. Culvert (**706**) capstone removed. Looking East

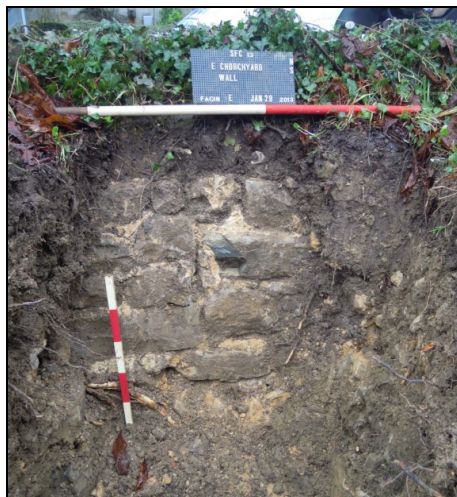
The eastern end of Trench H extended beyond Trench E as far as the eastern wall of St Peter's church yard. At this point the foundations of the church yard wall were cleaned and photographed. The foundations comprised at least 6 courses of roughly squared Lias rubble stones measuring up to 400 x 120mm bonded with lime mortar (sample <3>). The wall was battered. The foundations were set within a 2m wide rubble filled cut. The surface of this rubble back fill stood slightly proud of the surrounding church yard ground level to produce a low earthwork parallel and adjacent to the wall.

Photograph 4. Trench H eastern church yard wall, looking East

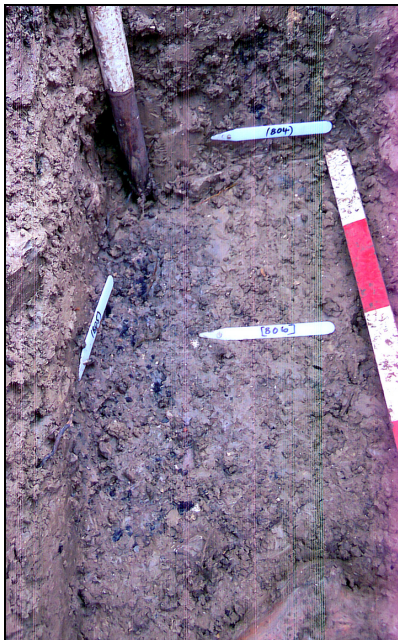
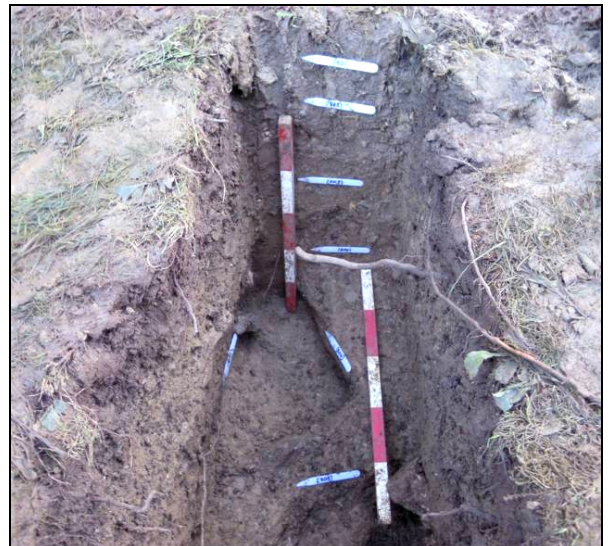
Photographs 10. Charcoal-rich fill (805) on the left and pit [806] on the right. Looking south.

All that was visible of the cut [806] was a squared corner, c 8cm deep as exposed. It had asymmetrical sides with a gentle slope on east side and sharp undercut slope on west, and a base sloping gently down towards the SW. The original shape of cut is unknown as it is truncated on the south by grave cut [707], on the north side by grave cut [808] and not exposed to the east.

The charcoal rich deposit [806] at the south end of Trench I was the only medieval archaeological feature not directly associated with graves (see 7.5.2). This feature was greatly truncated within the trench by later graves. However, the fact that it contained material associated with cooking (fragments of cook pot, charcoal, burnt bone and stone; see **Finds List, Appendix 2**), together with its apparently carefully constructed corner suggests that it may represent a cooking pit. The 13th to 14th century pottery recovered from grave fills in Trench I probably came from disturbance of the pit. Churchyard fairs were common during the medieval period, when the churchwardens brewed a batch of ale and baked cakes to raise funds for construction and maintenance of the church. This pit may well be a relic of such type of activity.

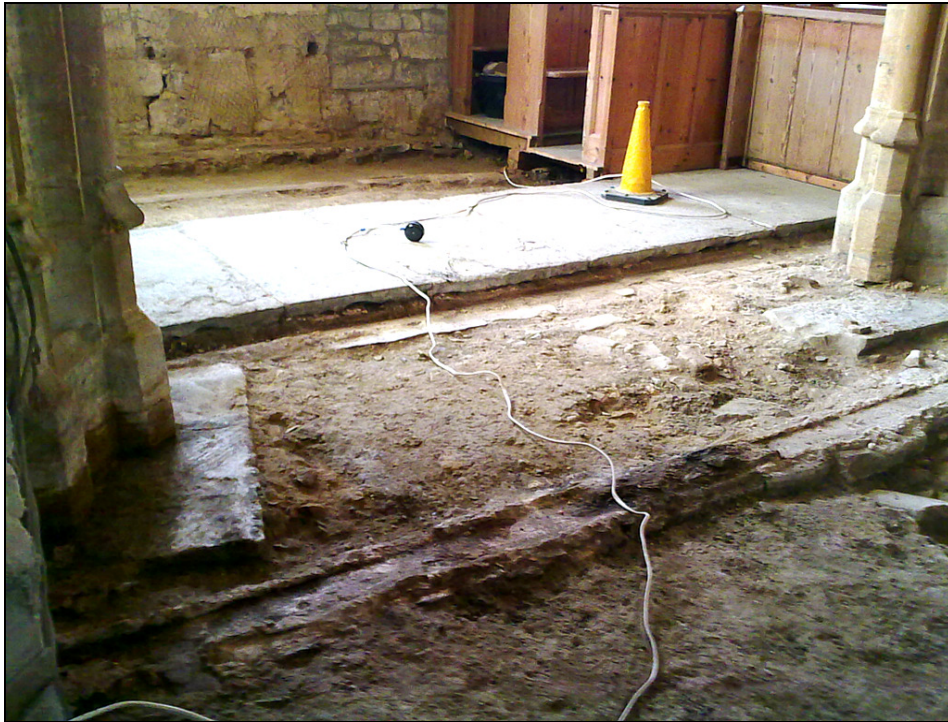
Photograph 12. The exposed north arcade pier [904] and earlier nave foundation (905). The half-pier to the left has not been given a context number.

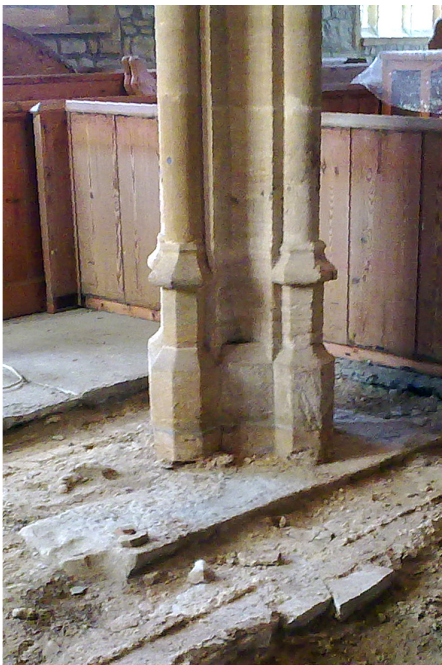
Photograph 13. North arcade pier [904] resting on large Lias slabs. Pew backings remain in the background. Foundations (905) lies below.

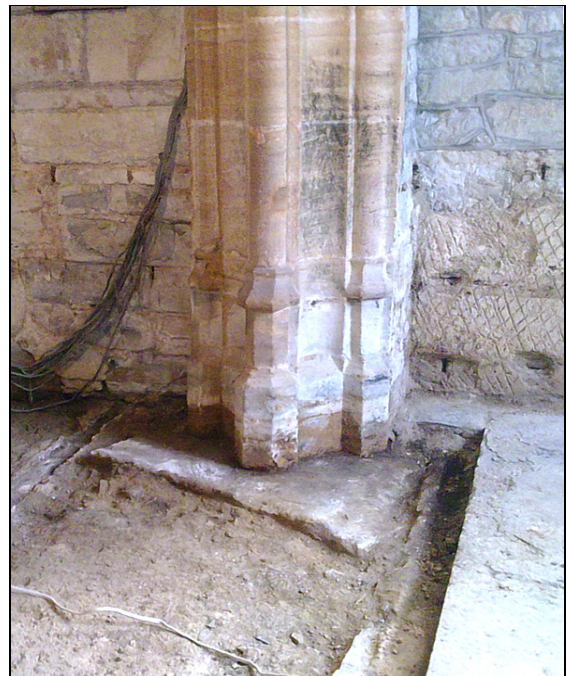
Photograph 14. North aisle half-pier resting upon a large Lias slab. This half-pier is attached to a small sliver of the pre-north aisle nave wall.

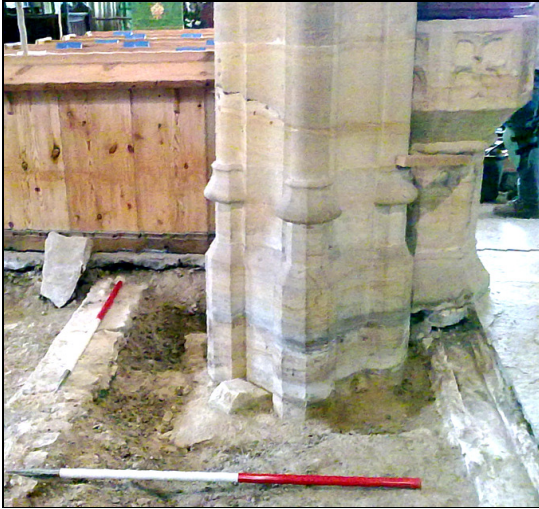
Photograph 15. South arcade pier [903] cutting through mortar bedding layer (902). The font is in the background.

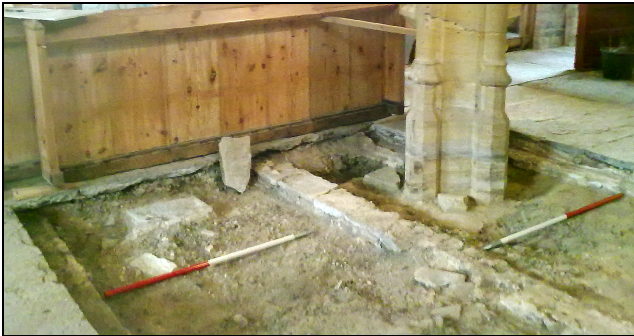
Photographs 16 and 17. Glassworking area [906] excavated (left) with the hearth before excavation (right).

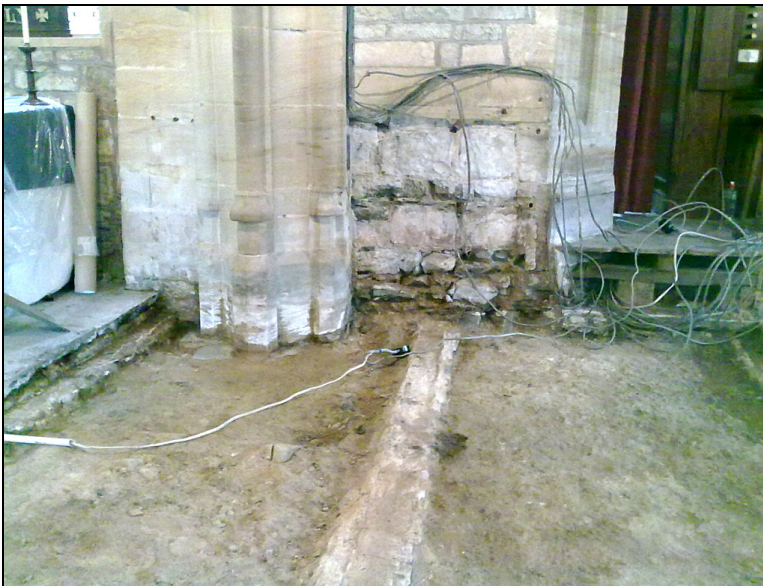
Photograph 18. South half-pier (not given a context number) and mortar bedding layer (902). The wall behind the half-pier displays two, and possibly three, phases of masonry.

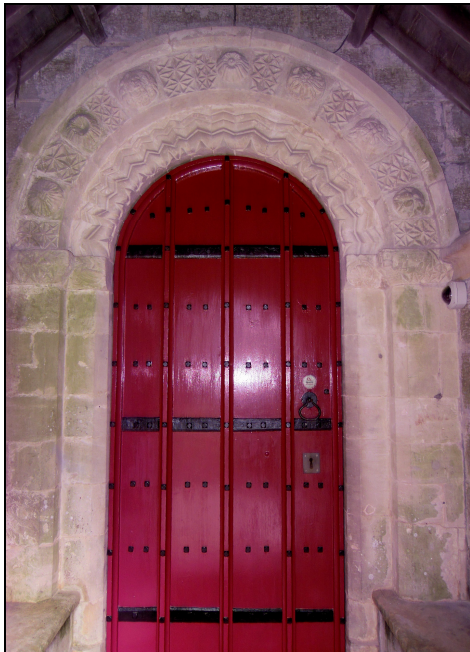
Photograph 19. A doorway with Norman dog-tooth moulding was set into the porch as part of the construction of the north aisle and porch in 1841. The original location of the door has not been recorded, but the size and elaborate decoration suggests that it was the original main entrance into the church, probably through the south wall of the nave.

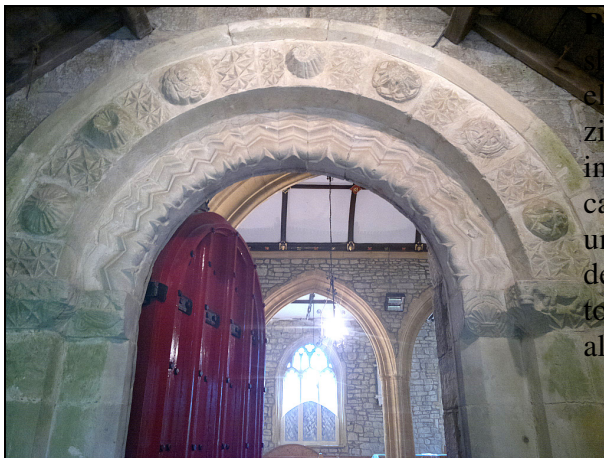
Photograph 20. A closer view of the arch shows that it is composed of three elements: an inner order of dog-tooth zig-zig moulding, an outer order of roundels interspaced with diaper panels, and the capitals with animal carvings. The crisp, unweathered appearance of the carvings demonstrates that they were never exposed to the elements. Rather, they seem to have always been inside the church.

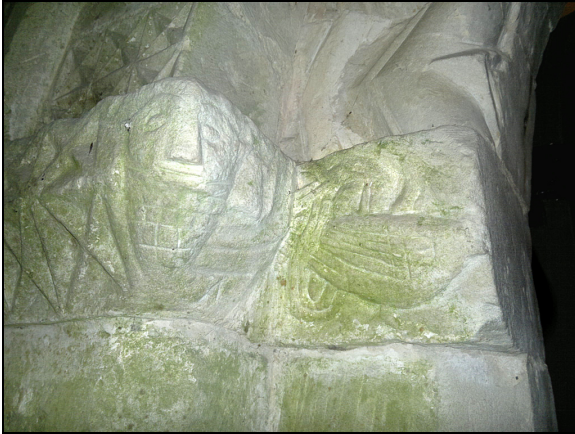
Photograph 21. The left capital is composed of two carved blocks. The block on the right is a bird (facing to the left) with a long sinuous neck which passes through the bird's beak. The bird's beak and part of the neck are partly obscured by the other block, which carries a carving of a bearded face at the corner with a panel of diaper pattern carved on the outward facing side. These two carvings appear to have been re-used from an earlier arrangement.

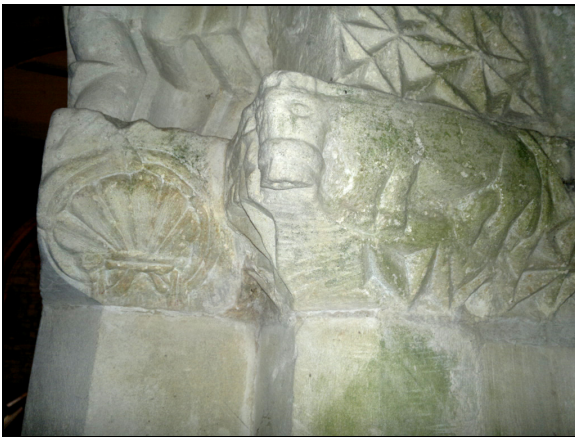
Photograph 22. The right capital is also composed of two blocks. The inner block to the left carries a shell pattern on the chamfered corner while the outer block on the right is carved to represent a hoofed quadruped amongst further diaper patterns. The dog-tooth moulding does not match the stone with the shell pattern.

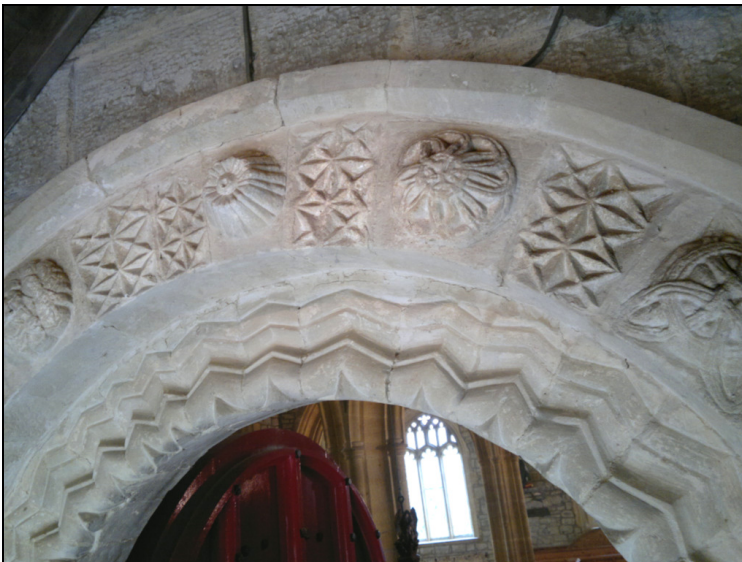
Photograph 23. A detail of the arch shows the two orders of decoration. The roundels, which display a wide range of styles and decorative motifs, are united through the use of the diaper pattern panels, which also echo the patterns on the outer elements of the capitals.

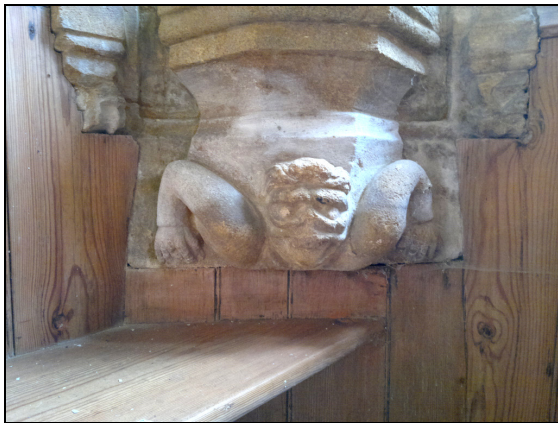
Photograph 39. In the northeast corner of the north aisle an elaborate canopied statuary niche is supported by a grotesque figure. Many similar carvings may be seen throughout the church, especially in the tower.

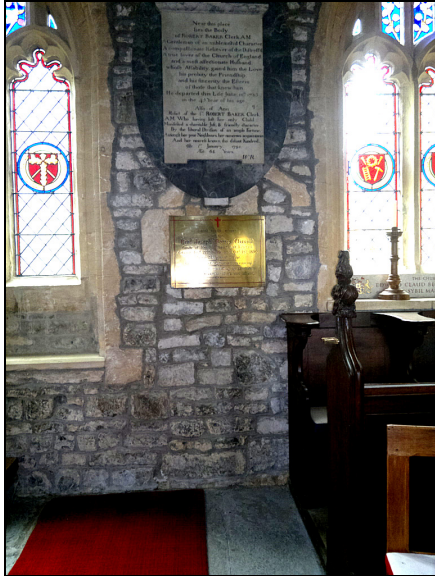
Photograph 25. The arch of the blocked doorway in the south wall of the chancel is obscured by a later memorial making it difficult to date the doorway itself. Its location is consistent with a priest's door.

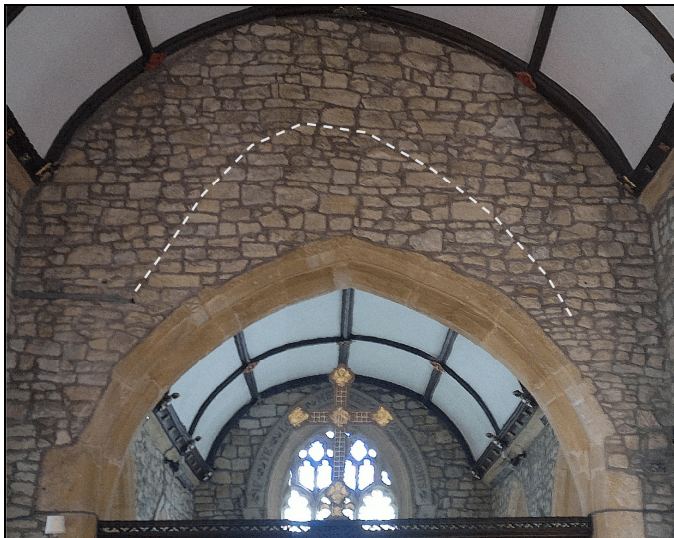
Photograph 26. The wall above the chancel arch shows signs of settlement, highlighted with the dashed line. This suggests that the present chancel arch replaces an earlier one. Each end of the line stops above a section of masonry made of rather smaller stones than the masonry above it. The left side shows a masonry line and irregular coursing caused by the demolition of the former north aisle wall and insertion of the north arcade. Slight signs such as these gives clues to the evolution of the present building.
